Tree Safety Report

Market Drayton Town Council

John Blessington, Arboricultural Officer,
Tree Team, Shropshire Council

Date Inspected: Between Summer 2022 and Summer 2023.

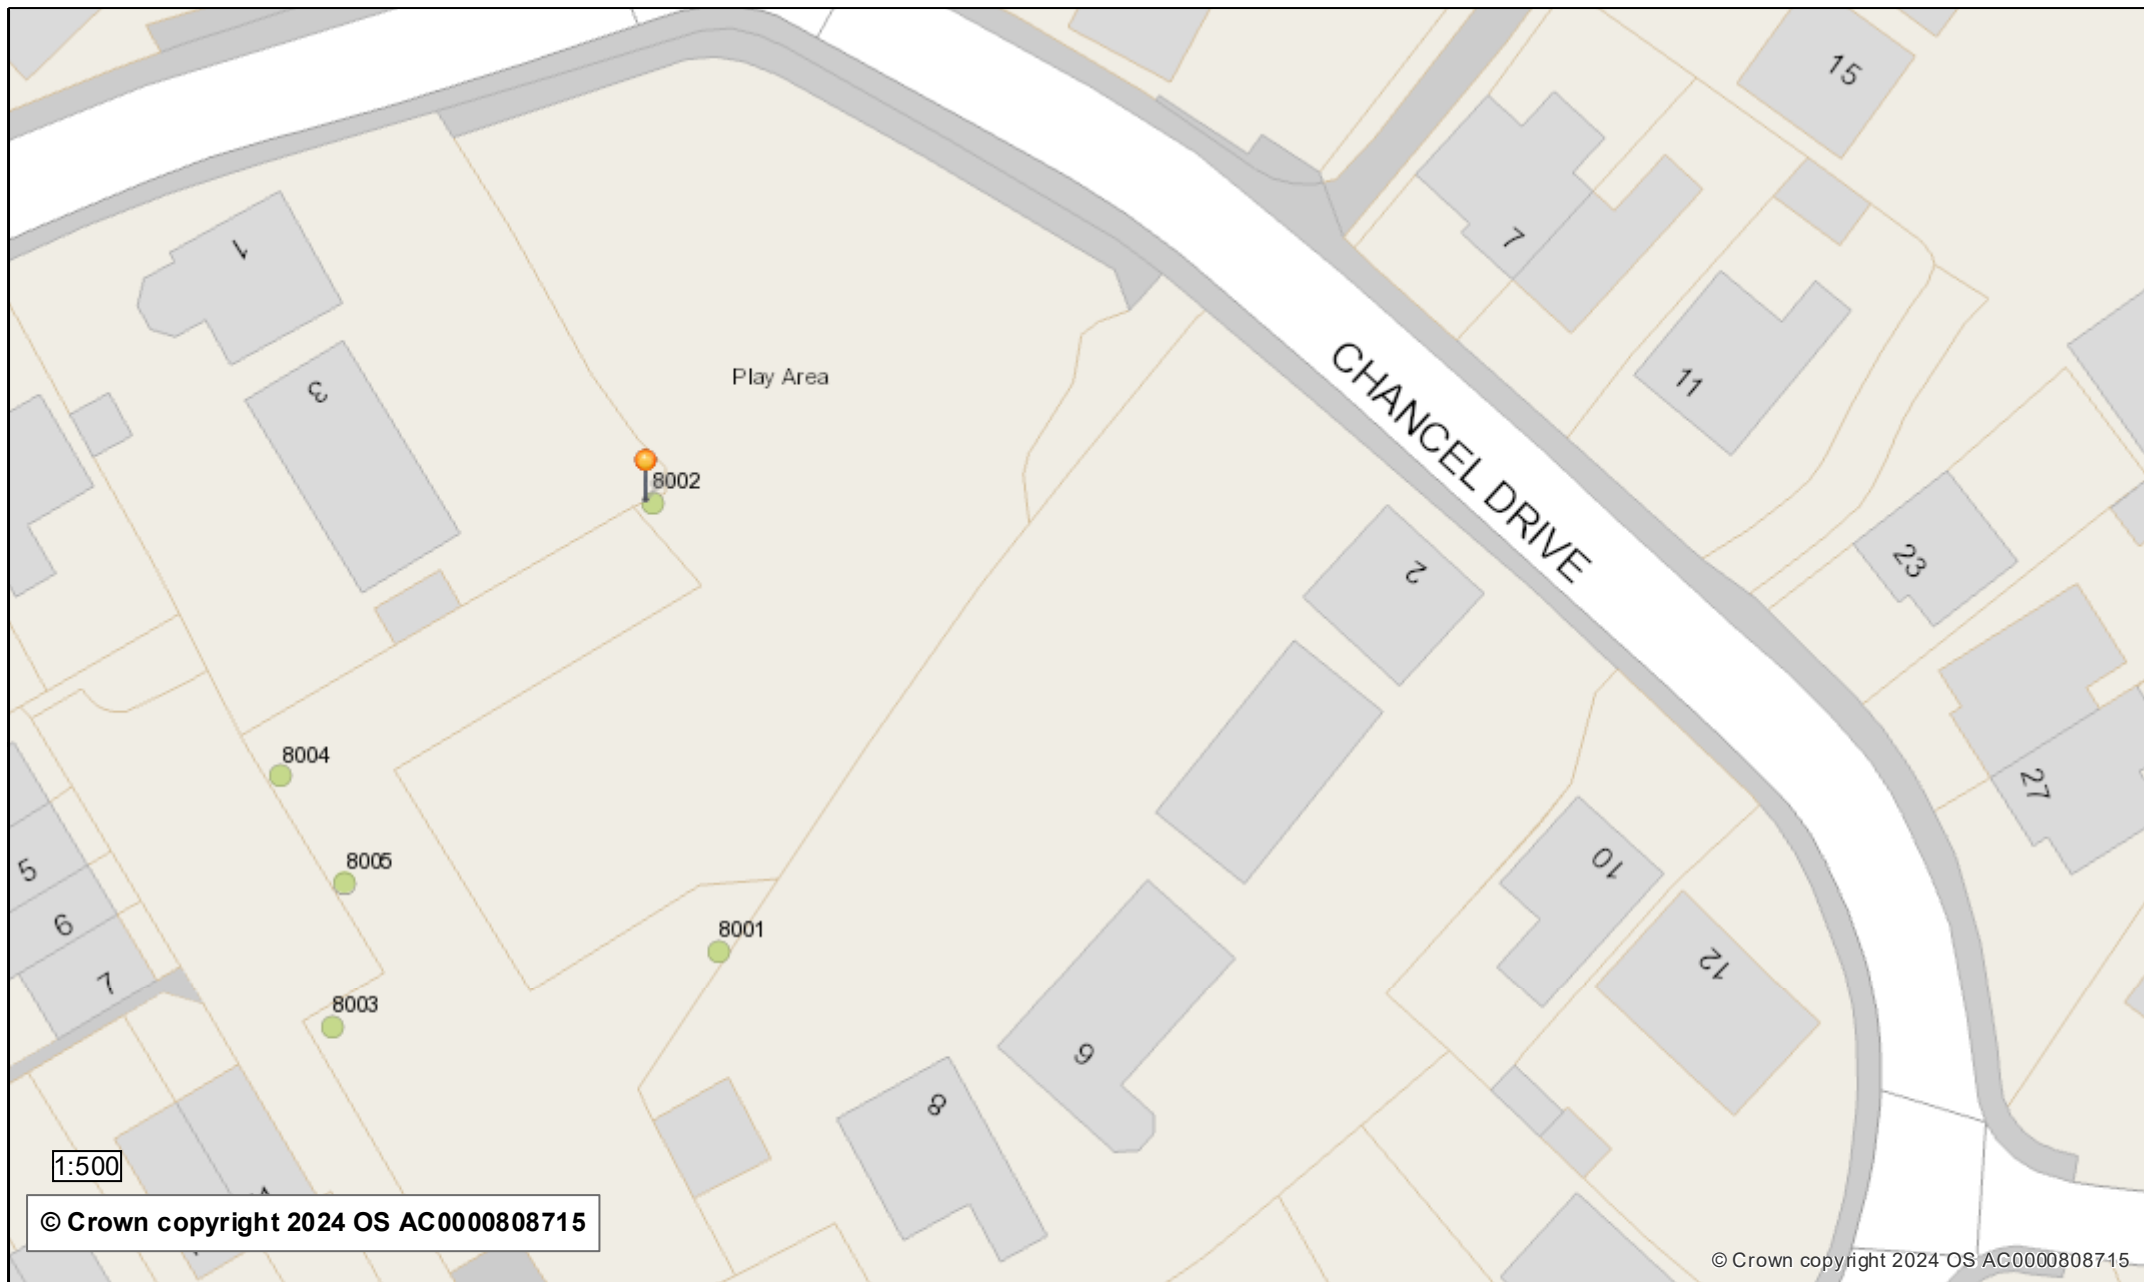
P0064 - Abbotsgate Play Area

Abbotsgate Play Area. This consists of four small trees and a previously large oak now pollarded to a much smaller specimen. There are no actionable defects on this site, so no works required.

Tree 8002 is in adjacent private garden

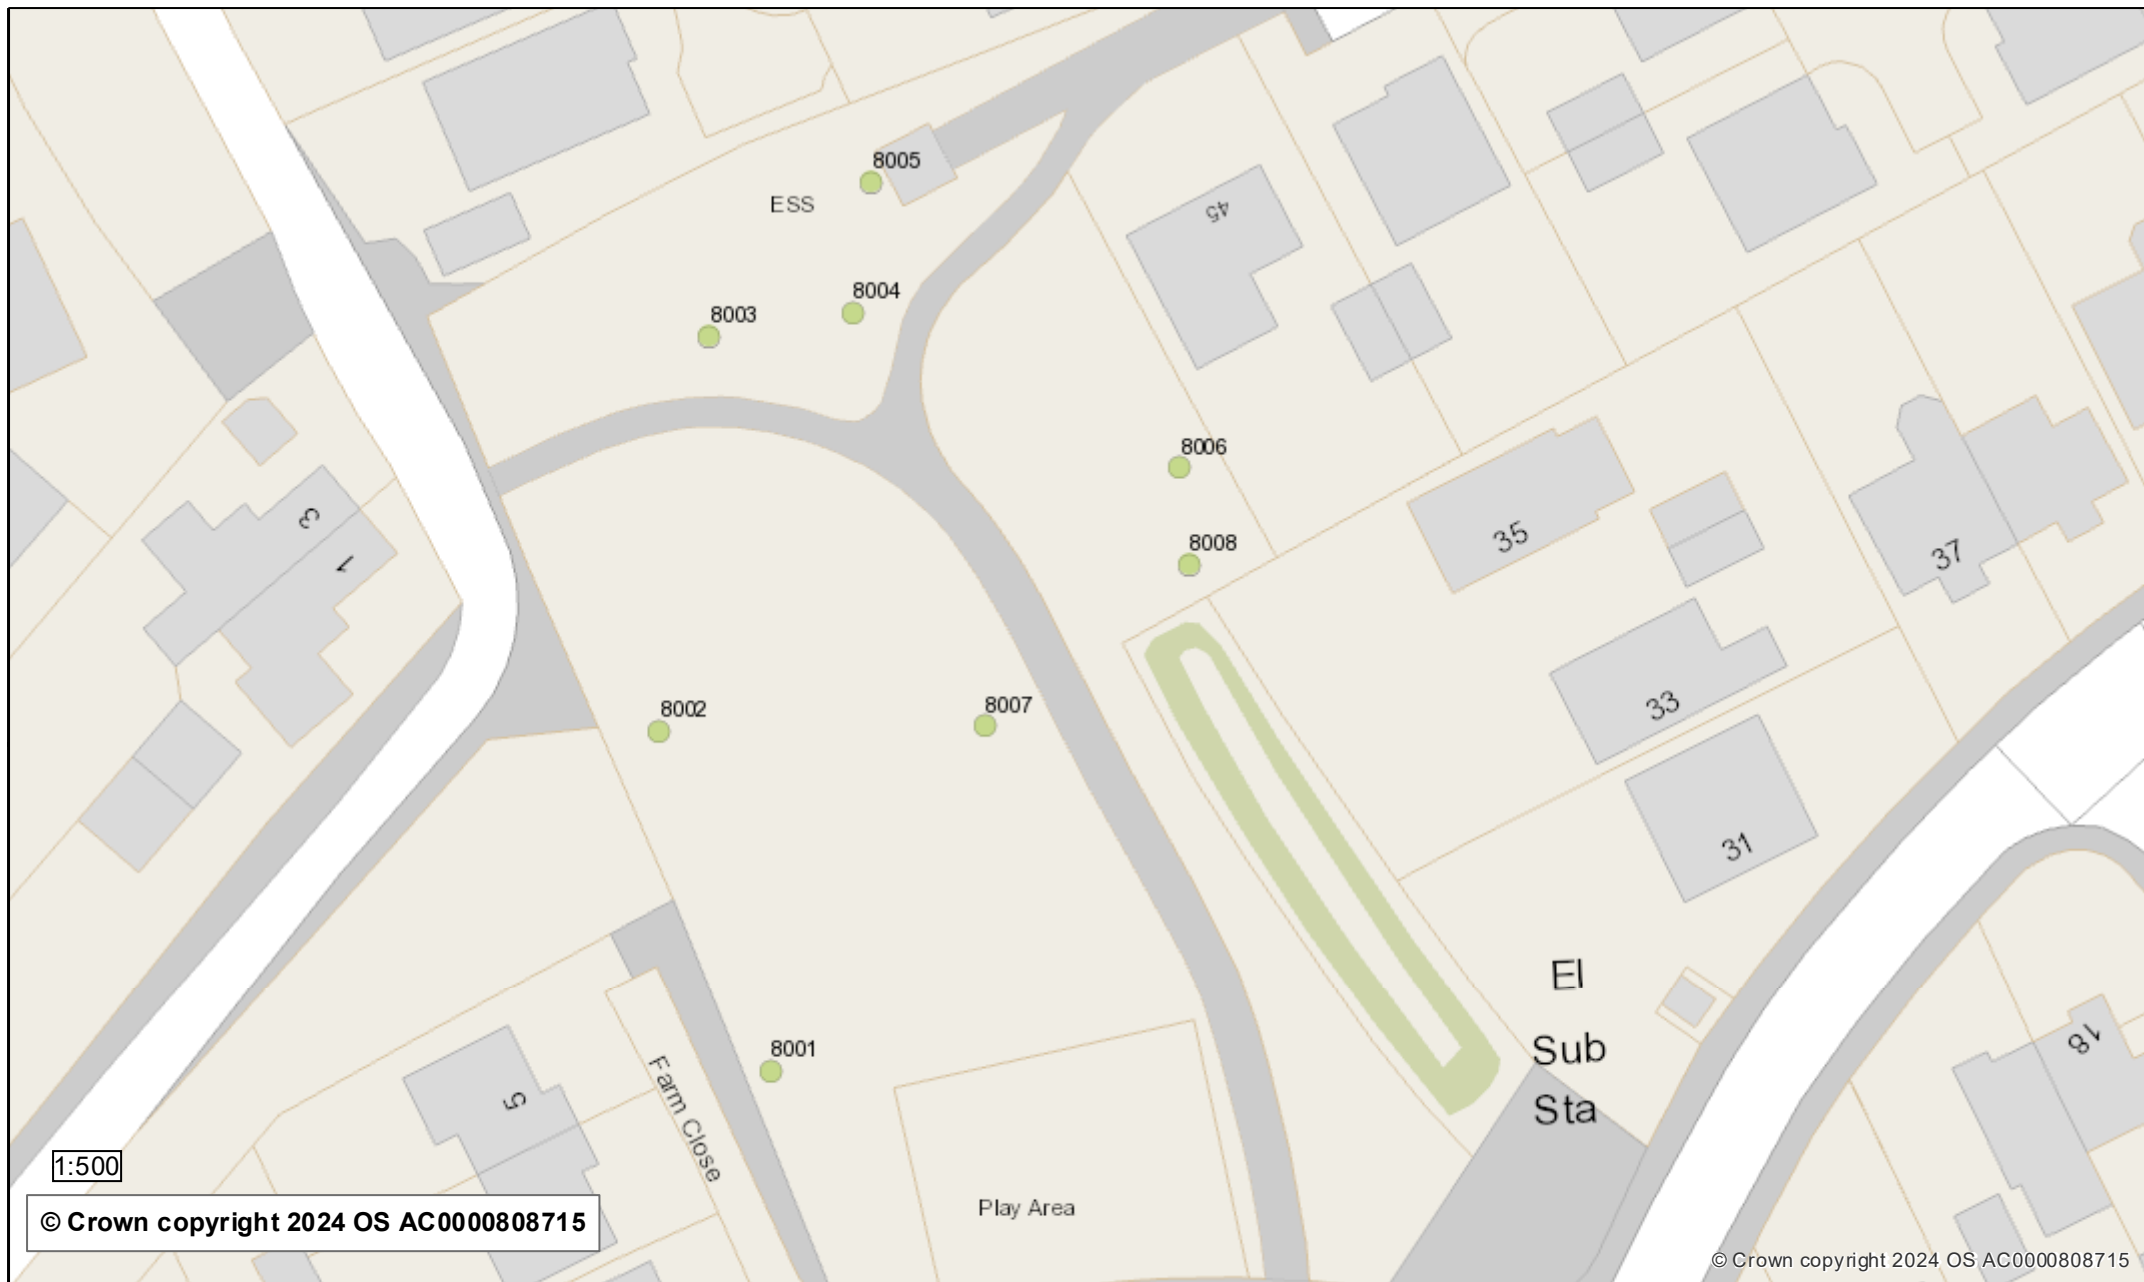
P0065 - Croft Way Meadows

Croft Way (Meadows). There are eight young trees here, several still with stake and tie. Establishing well. There are no actionable defects on this site, so no works required.

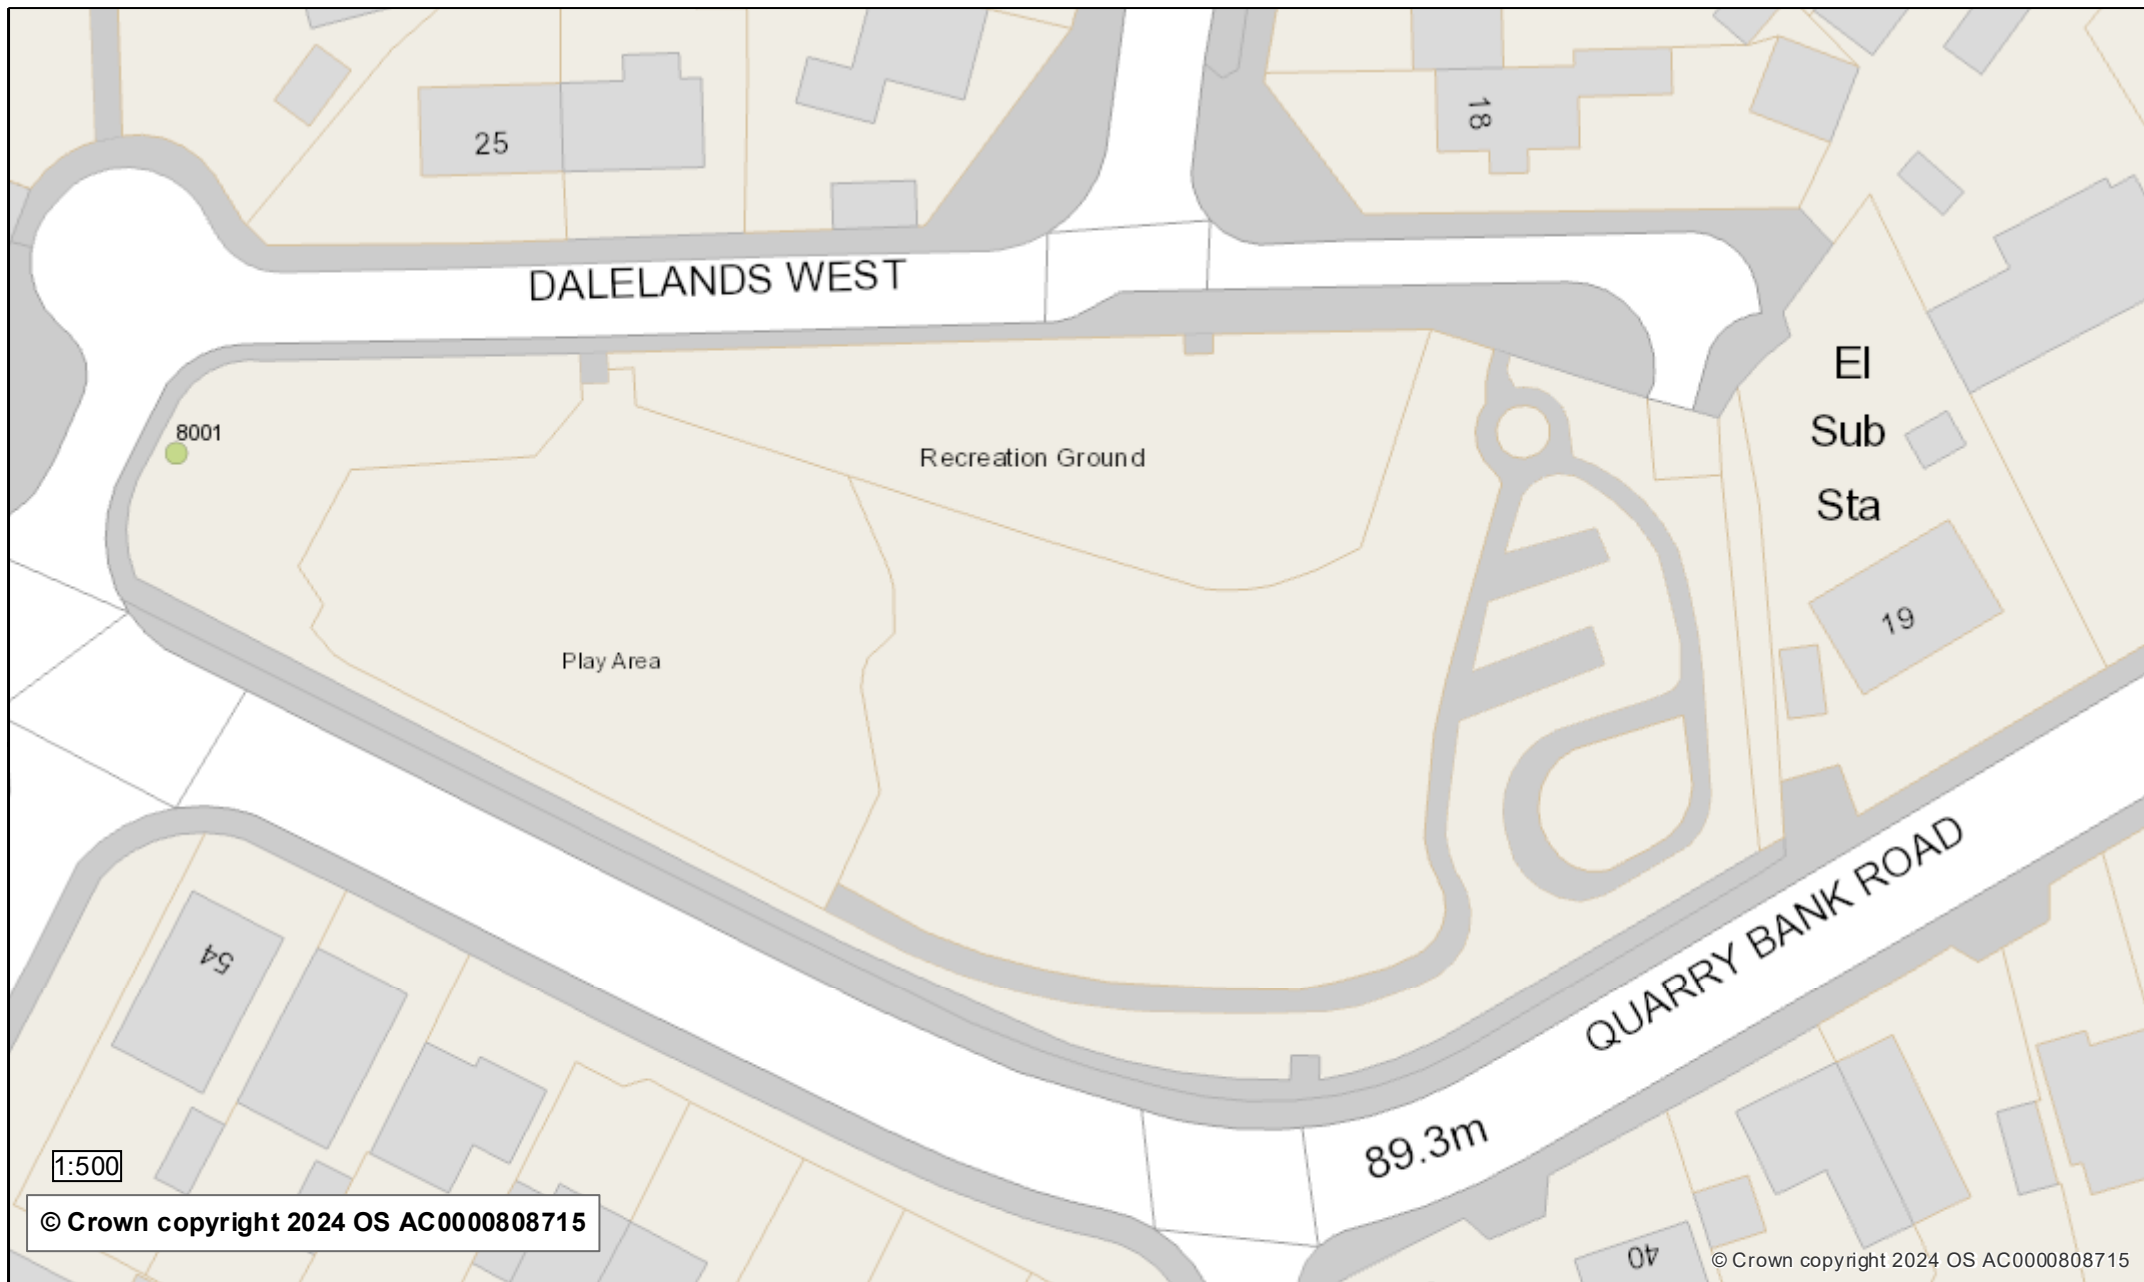
P0066 - Dalelands Play Area

Dalelands Play Area. Just one young-mature fir here in good health. There are no actionable defects, so no works required.

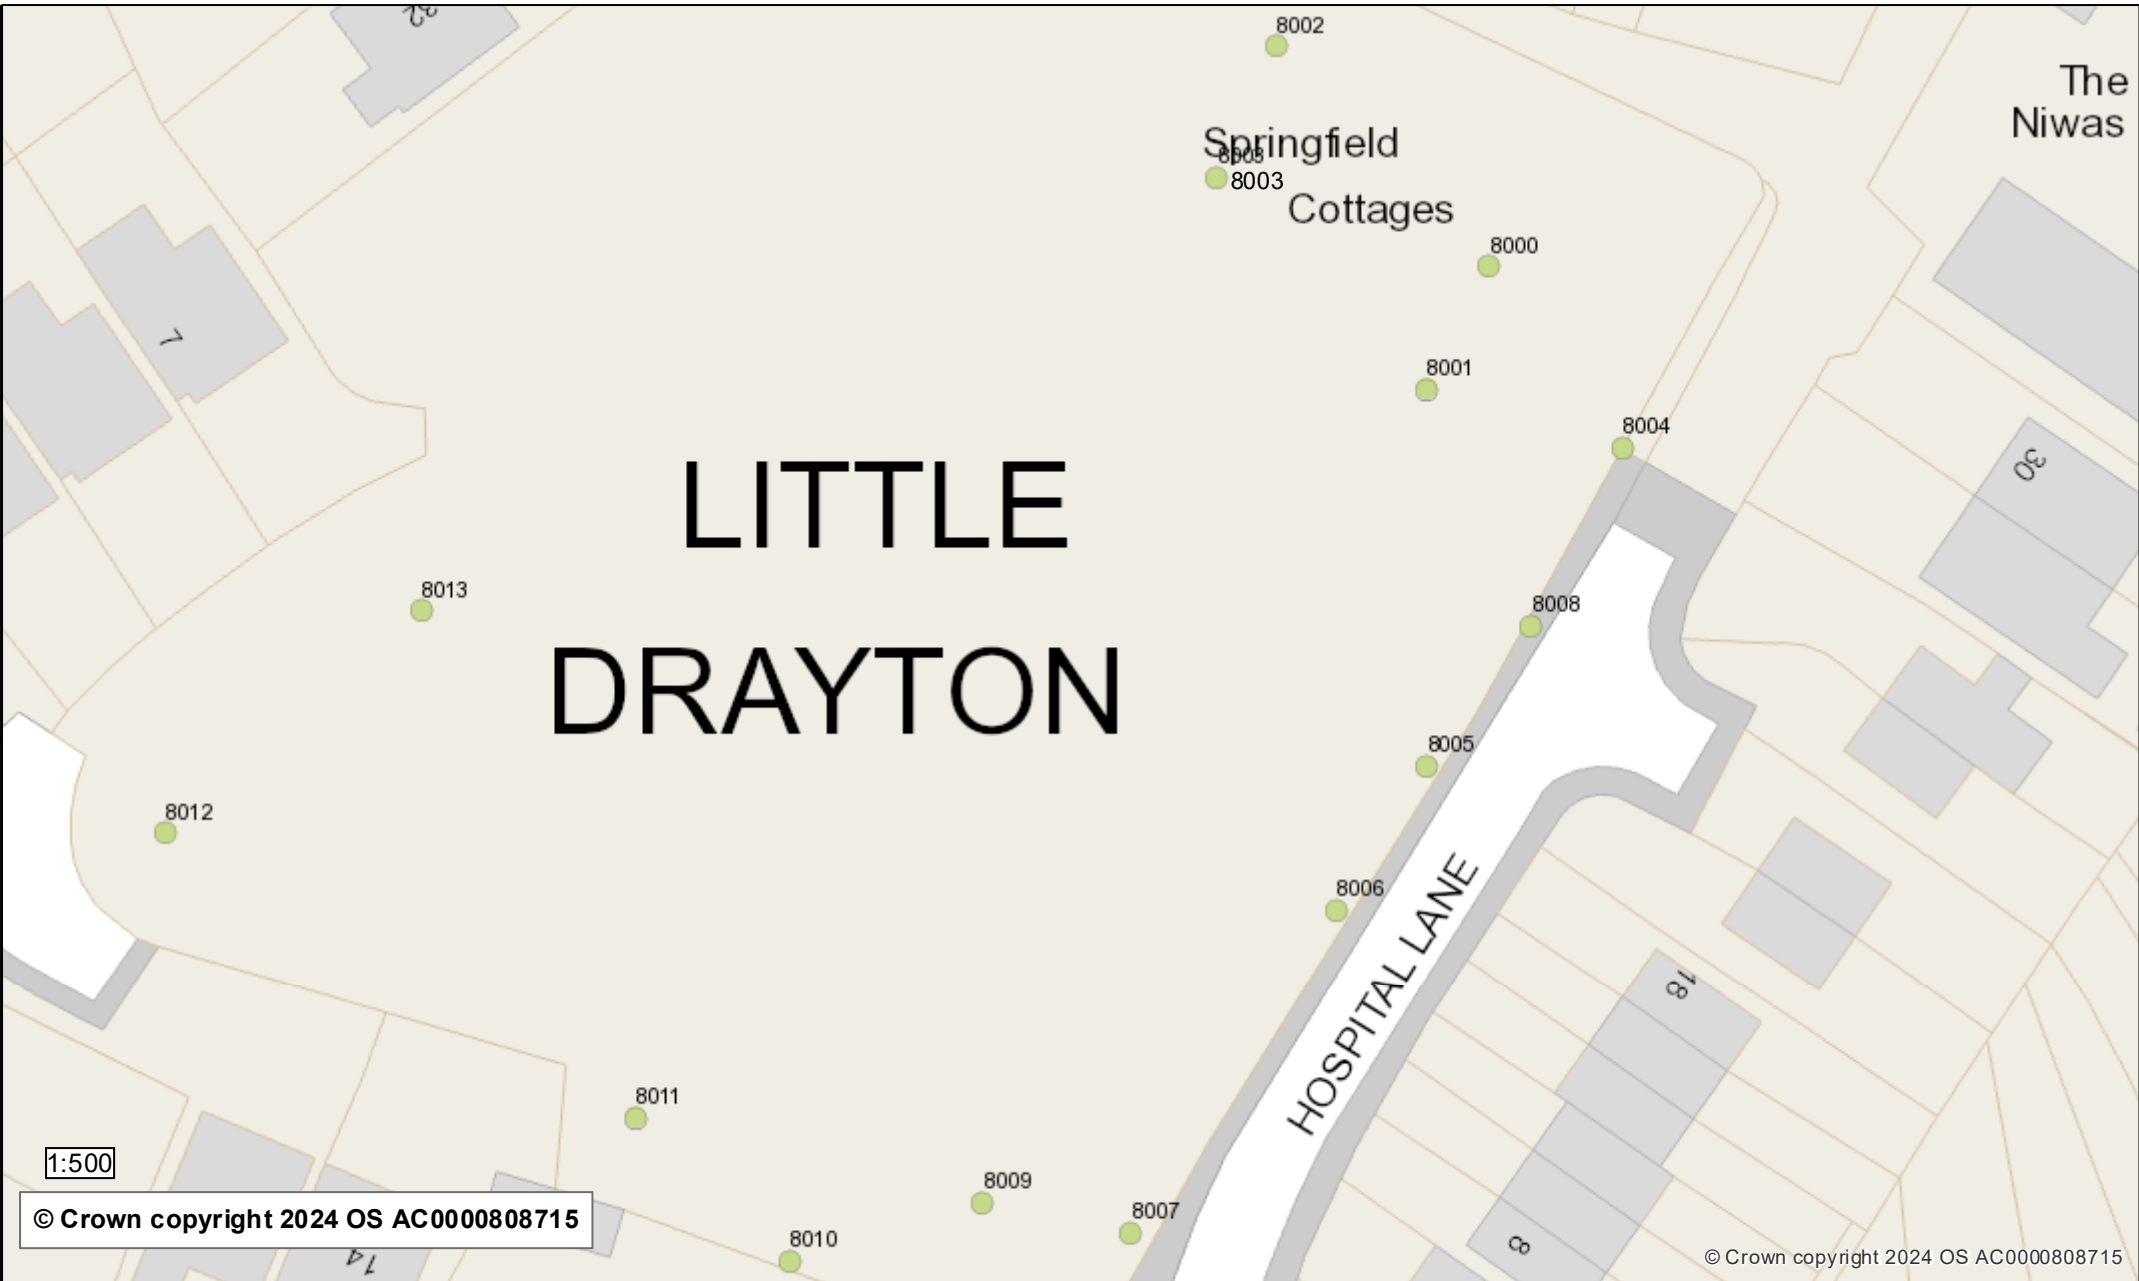
P0031 - Forest Road Recreational Area

Forest Park Recreation Area. There are 13 trees listed here including two lengths of mixed hedging, two quite unusually large elms (still in good condition) and three substantial sycamores alongside hospital lane, one of which has been pollarded and will need to be repollarded in the next few years. There are no actionable defects, so no works required this time.

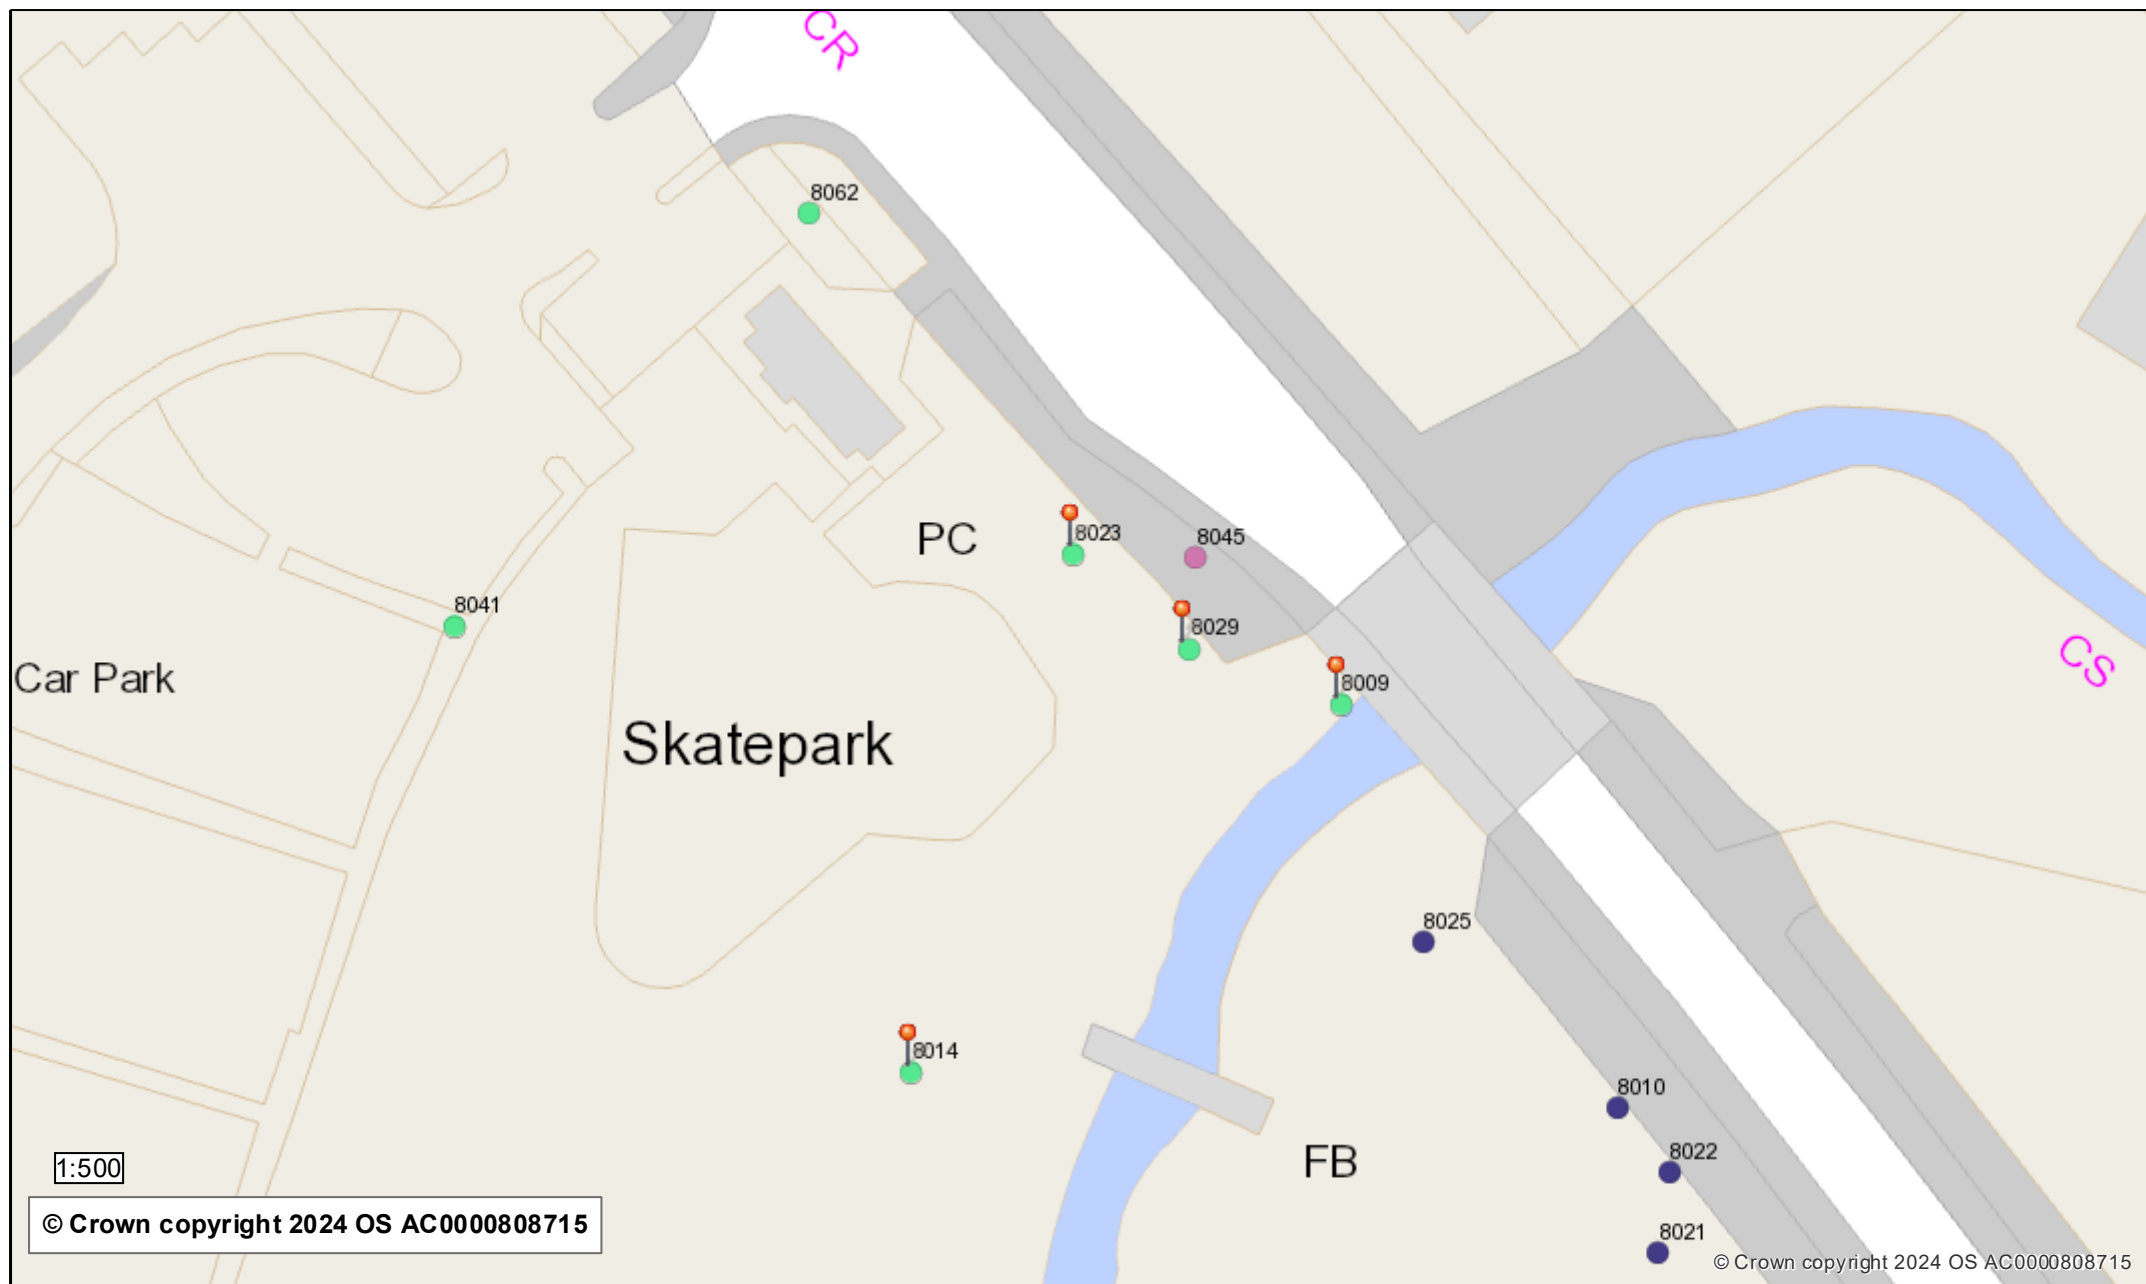
TNSDC009 - Skate Park

Skatepark. There are only four trees on this site but two are huge mature Lombardy poplar which must now have limited safe useful life expectancy and a willow by the river which is similarly limited but will probably be coppiced or pollarded in time rather than felled. At present there are no actionable defects, so no works required. The Lombardy poplars will inevitably produce a large amount of litter and modest debris in strong winds.

Note all the trees are shown as coloured dots, but only the trees with a red pin were inspected as part of the Skate Park survey - 4 trees in total

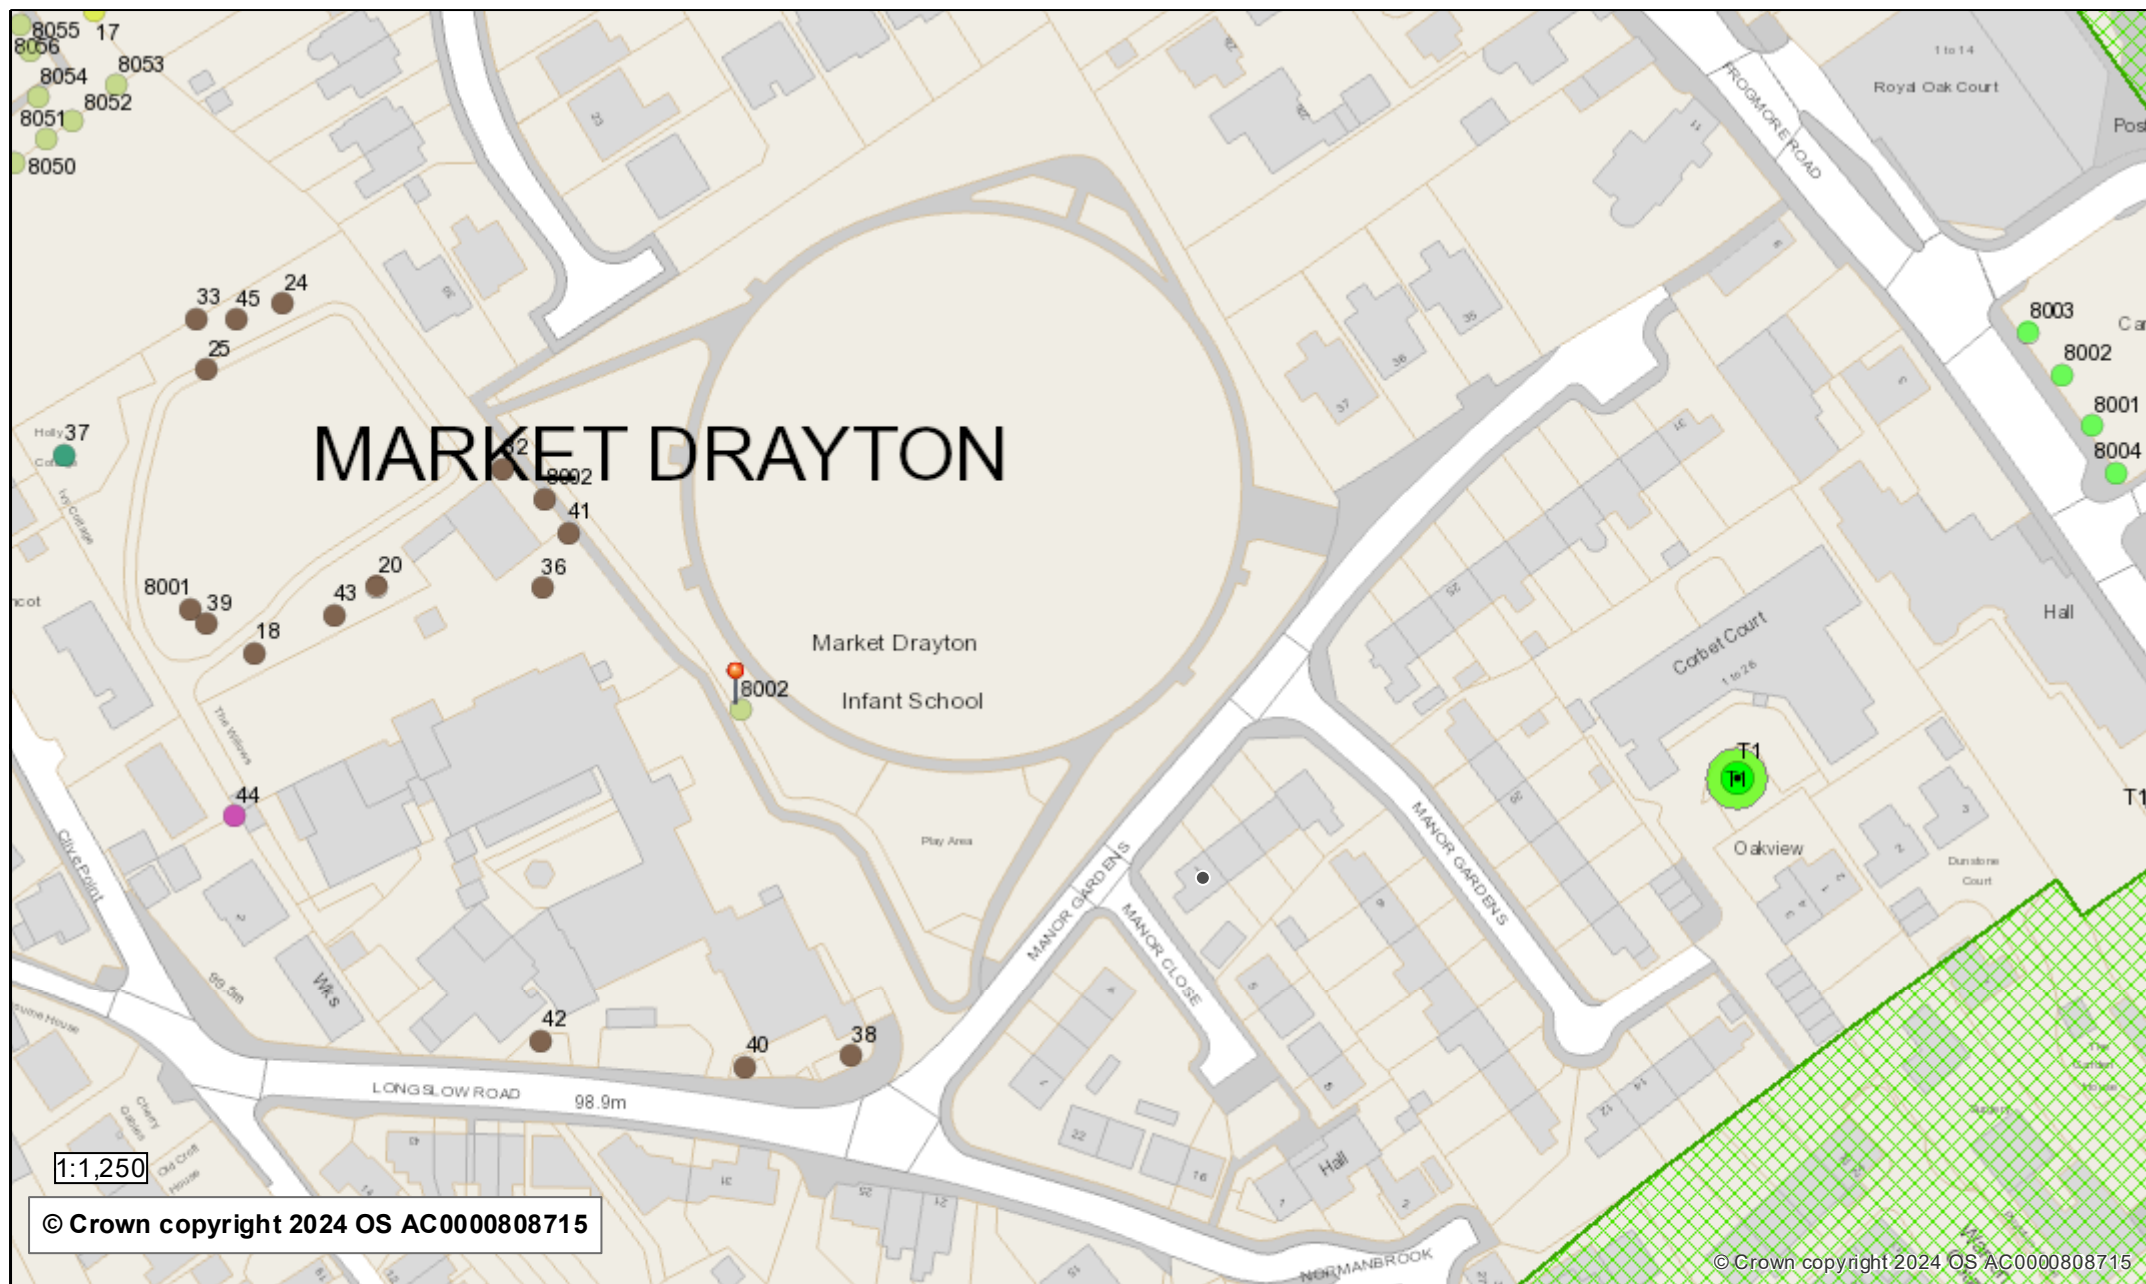
P0032 - Market Drayton Town Park

Town Park. There is just the one tree here but what a tree. This is a truly massive mature lime. Unfortunately, lime are well-known for generating a great deal of modest sized deadwood that soon blows out. This tree has remarkably little deadwood for a tree of its size but unfortunately the pedestrian entrance to the infants' school is located right beneath it creating a need for even greater care. There are no actionable defects noted, so no work required.

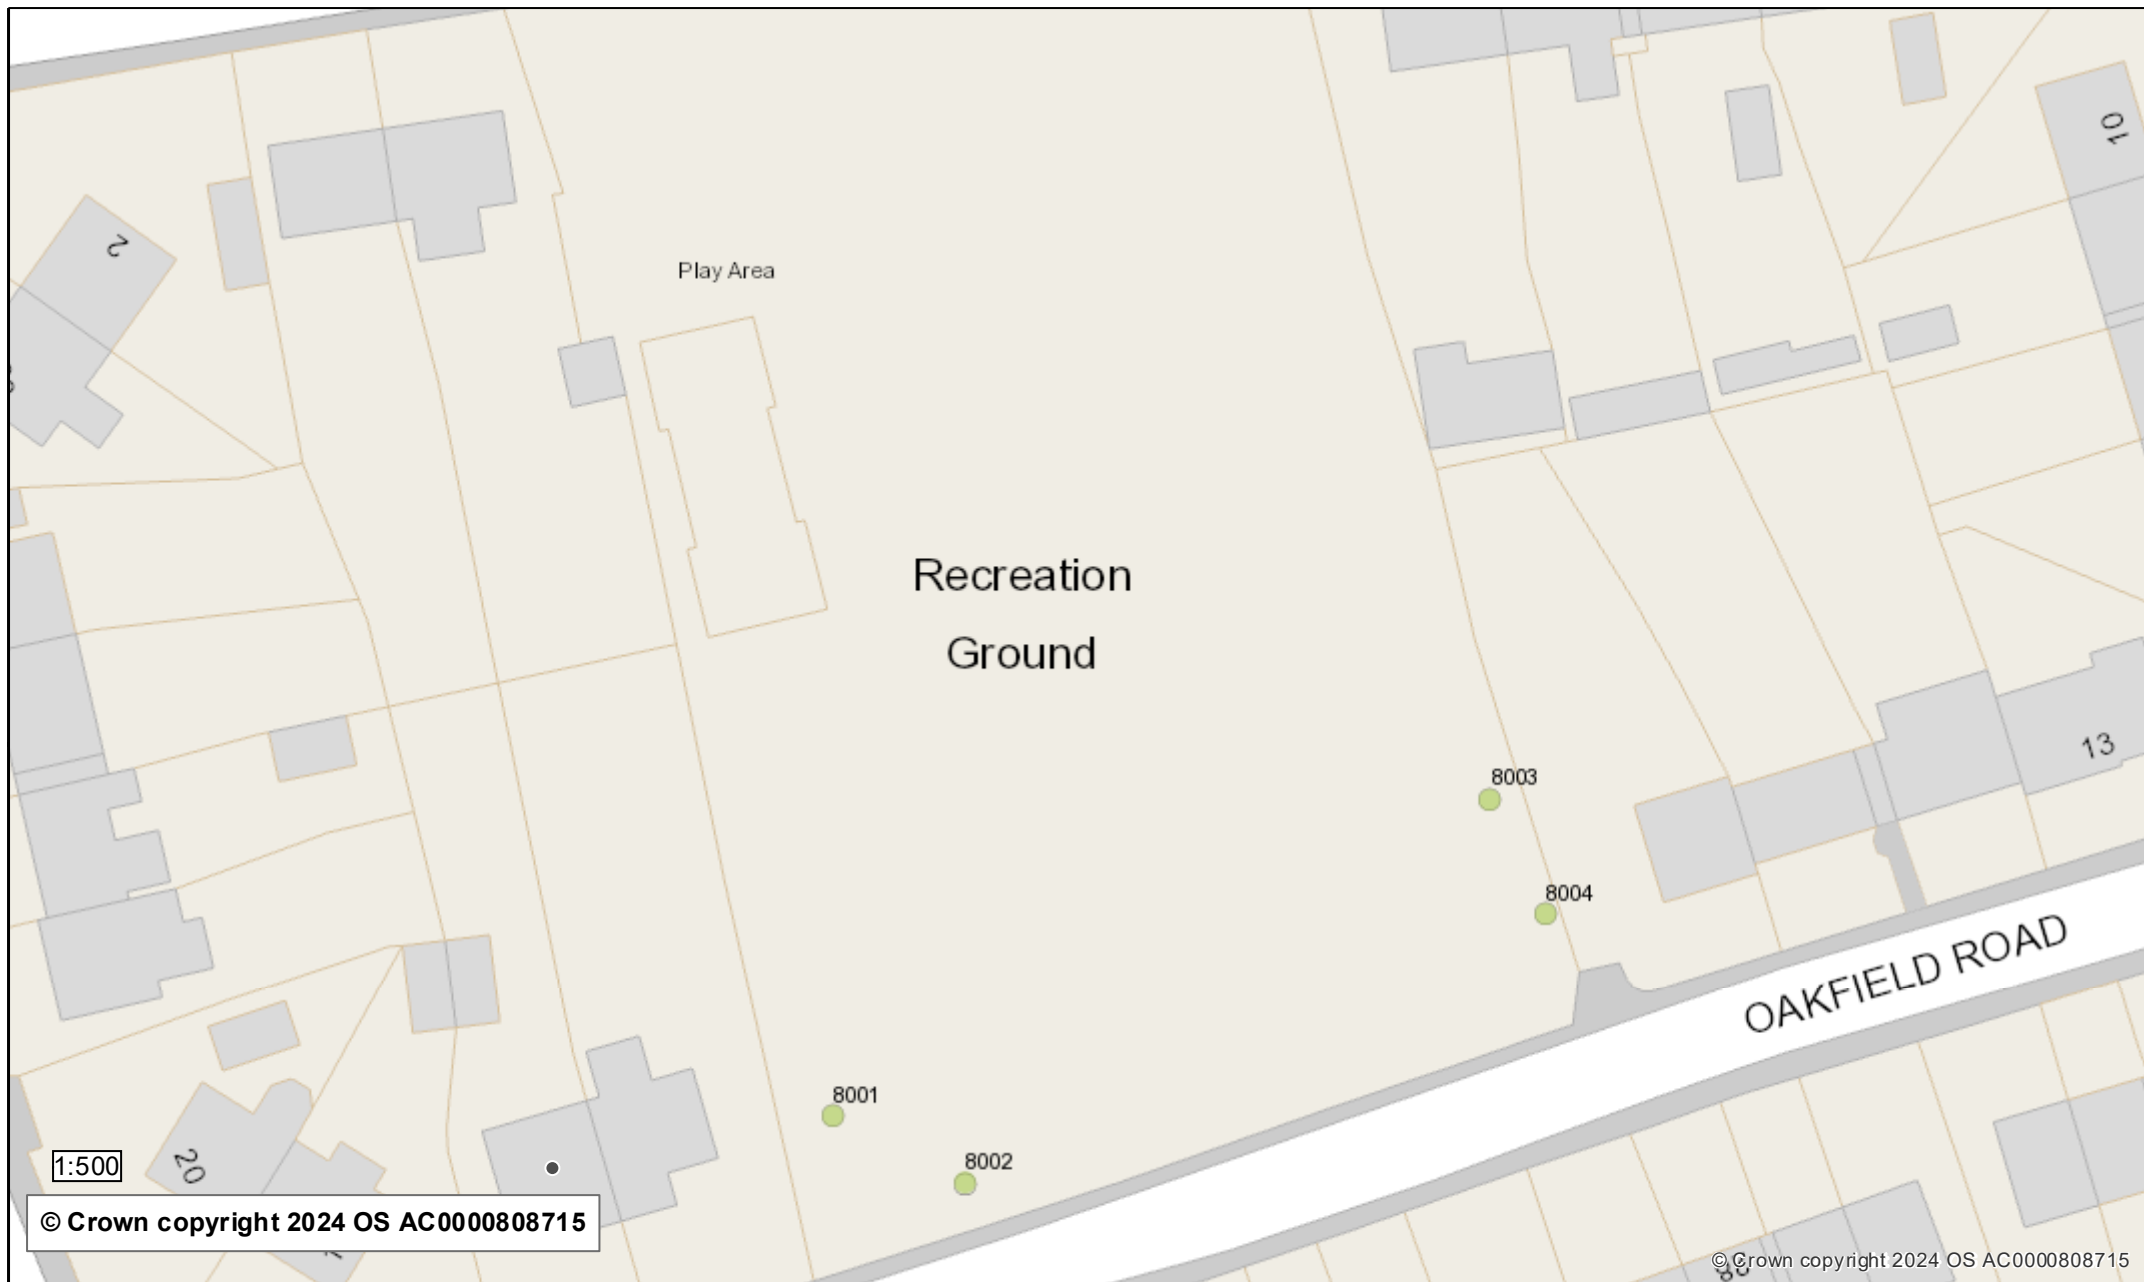
P0067 - Westlands Road Play Area

Westlands play area. This consists of a mature ash, two large sycamores and a small mixed species group. The ash seems to remain healthy at present despite Ash Dieback disease. There are no actionable defects and no works required.
